# IN SITU TESTING OF THE THERMAL PERFORMANCE OF WALL SECTIONS IN N.W.T.

REPORT FOR CANADA MORTGAGE AND HOUSING CORPORATION

G. K. YUILL AND ASSOCIATES LTD.

AUGUST 1 , 1989

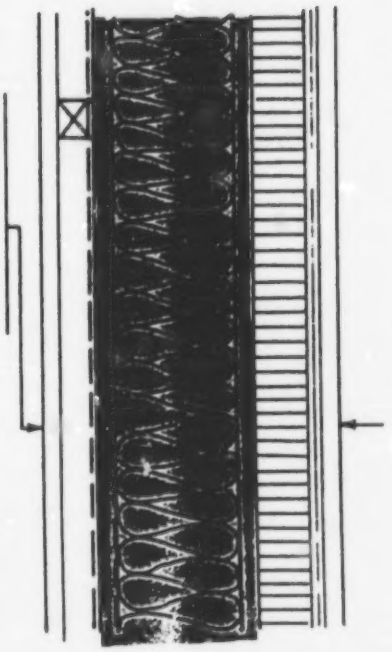
Figure 3. Exterior Wall Section of House No. 3

The measured effective RSI value of the wall section in House No. 3 was found to be 42% lower than the calculated theoretical value. Housing officials in Rankin Inlet indicated that the existing wall sections in many of the retrofitted houses were damaged by moisture. However, the infrared thermography scan did not indicate signs of moisture damage. It is important to note that there was an air space behind the gypsum board wall which the guarded hot box calorimeter was attached to. Cold spots that were close to the metered area but not immediately behind it may have provided a route for heat to escape from the adjoining air space.

The oldest house tested was constructed in 1976 and retrofitted in 1986. It was the only house where the insulating value of the wall section tested was significantly lower than the theoretical value. Mechanisms responsible for this lower insulating value were not clearly identified in this project. However, speculations were made. As mentioned earlier in this report, a longer monitoring period would have been desirable as the effects of stored energy within this wall section may not have been adequately minimized. The monitoring period for this wall section was broken on several occasions. It is difficult to predict how this may have affected the final result.

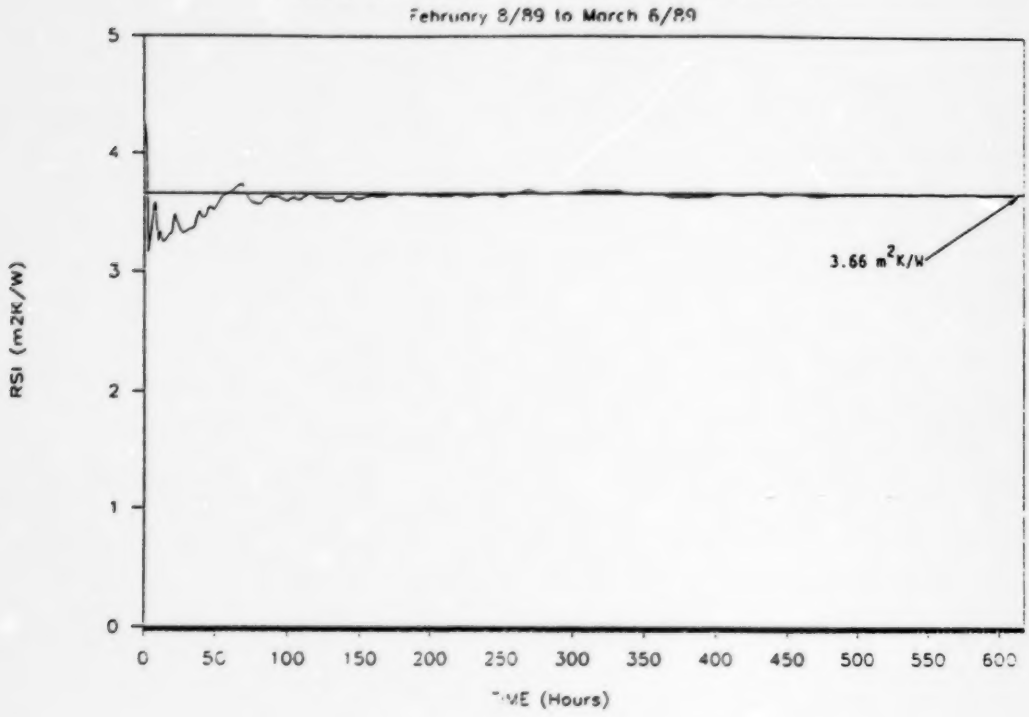
Figure 7

HOUSE NO.1: 1984 NINEPLEX
February 8/89 to March 6/89
RSI (m2K/W)
3.66 m2K/W
TIME (Hours)

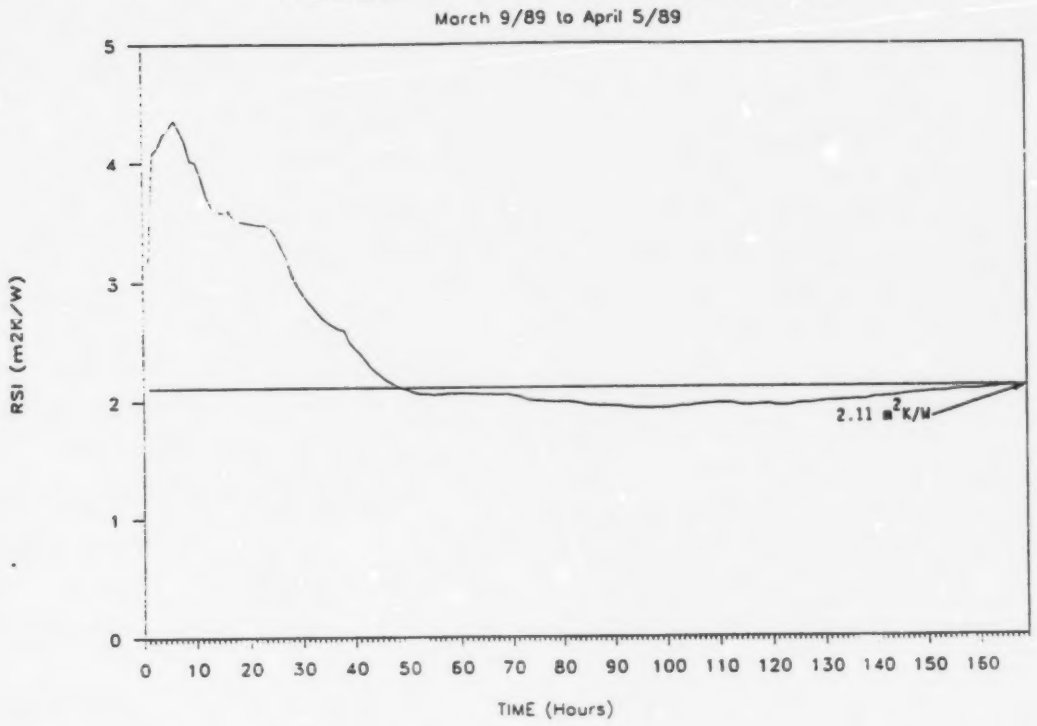
Figure 11

HOUSE NO. 3: 1986 RETROFIT
March 9/89 to April 5/89
RSI (m2K/W)
TIME (Hours)
2.11 m²K/W
0
1
2
3
4
5
0 10 20 30 40 50 60 70 80 90 100 110 120 130 140 150 160

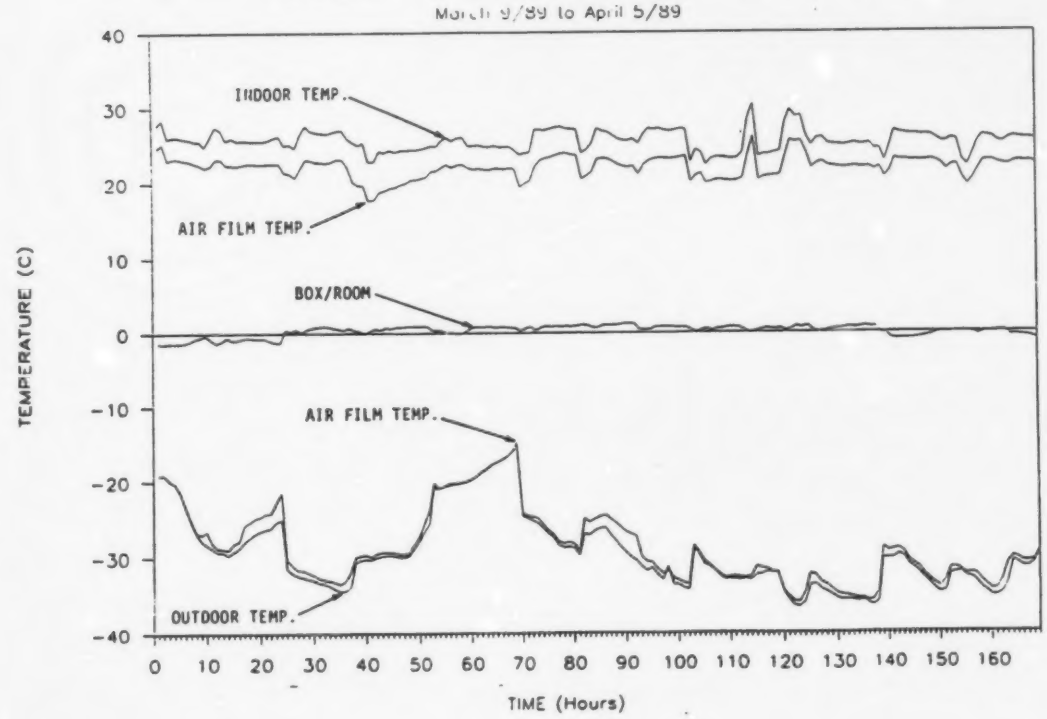
Unlike the other three houses tested, the retrofit unit had a considerable amount of space on the north wall for accommodating the guarded hot box calorimeter. This was due to fewer windows and no baseboard heating on the selected wall section. The infrared thermography scan on this wall revealed several cold spots. Most were at the ceiling/wall and floor/wall interfaces. However, because the north wall was quite large an area showing essentially no cold spots was identified for locating the guarded hot box calorimeter. In this area, only the strapping behind the gypsum board wall appeared dark on the monitor of the infrared scanner.

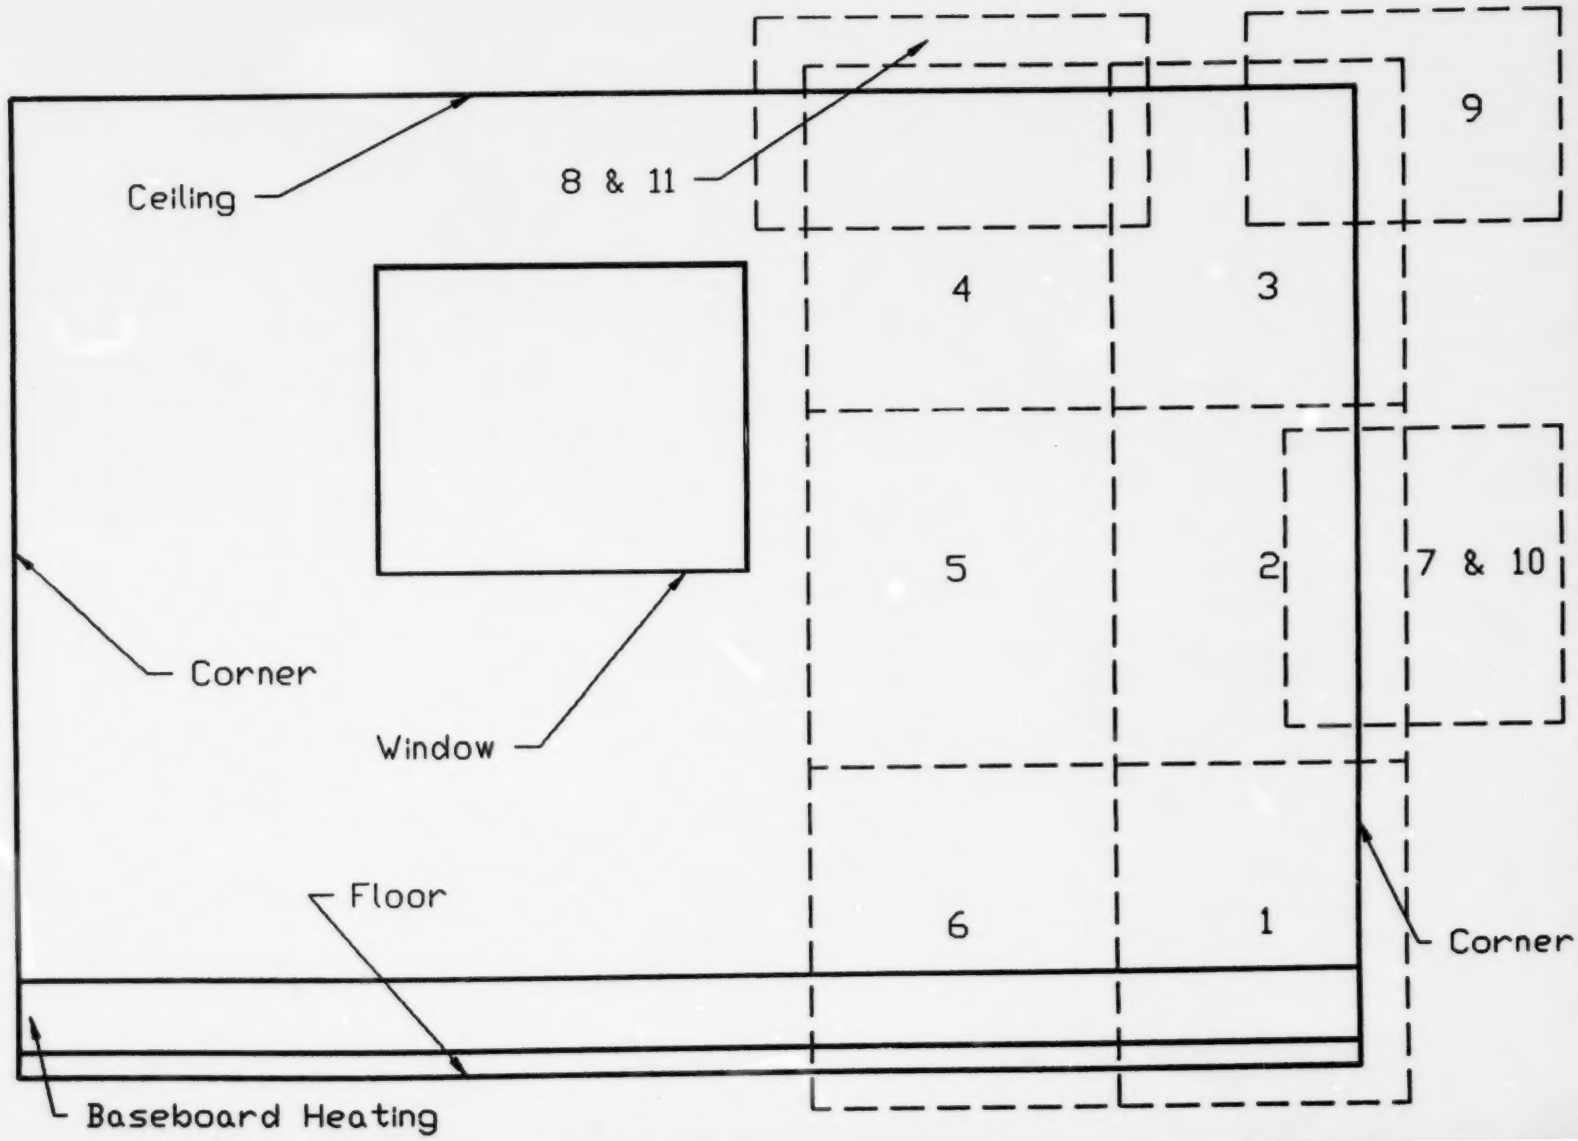
House No. 1: 1984 Nineplex Unit

The infrared thermography scan was conducted from inside the house where low lighting made for ease in viewing the black and white monitor of the scanner. From this view point, grey or black images on the monitor represented cold spots on the wall. No apparent cold spots were observed in the vicinity of the metered area on the wall section selected. One cold spot was observed on an adjacent wall in the first wall cavity from where the two walls met.

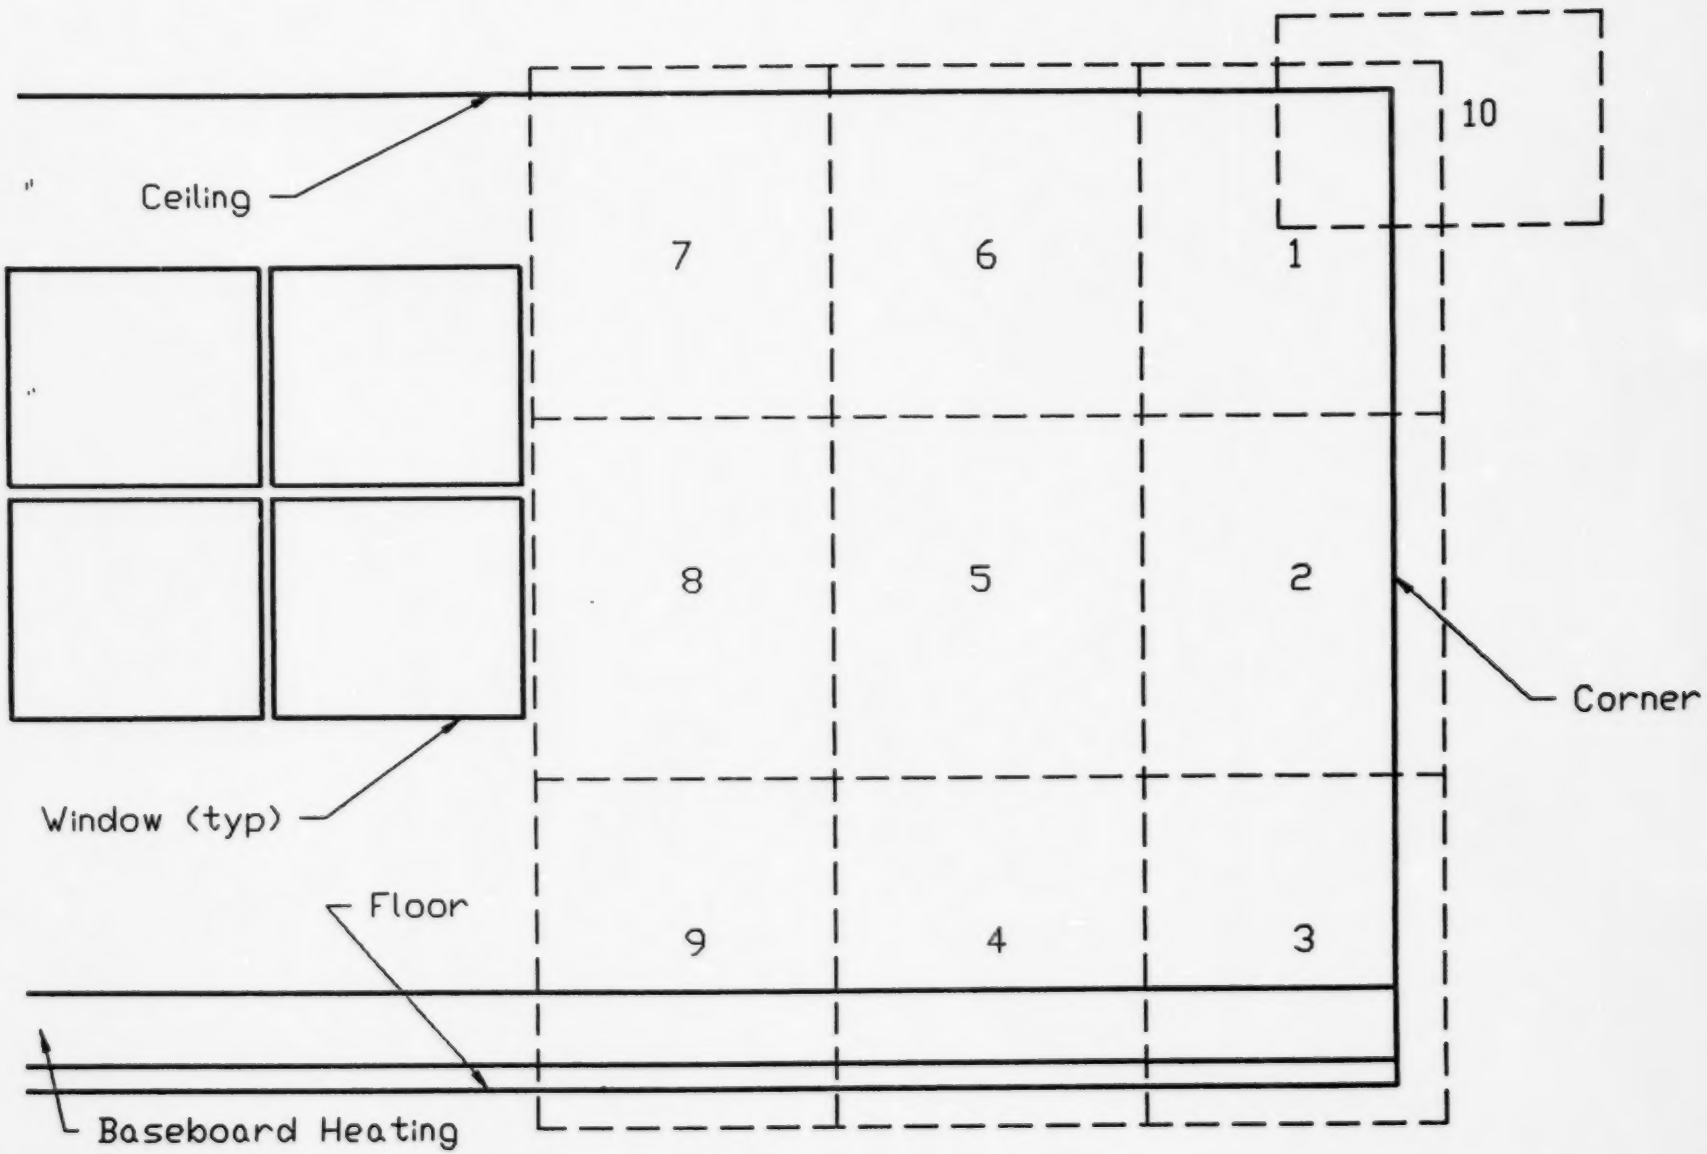
House No. 2: 1986 Duplex Unit

An infrared thermography scan of the selected wall section showed no signs of wall deterioration.
